## Crack monitoring survey during rough water trials period #2

02/08/2011 – 02/14/2011

Prior to the second set of rough water trials onboard USS Freedom (LCS-1) several cracks were found. These cracks were above the main deck. Prior to getting underway a repair or mitigation procedure was used for most of the cracks. The cracks that were not repaired/mitigated were found to late for that process to take place or while underway. In Table 1 all known cracks along with their locations are listed, current as of the date of this report.

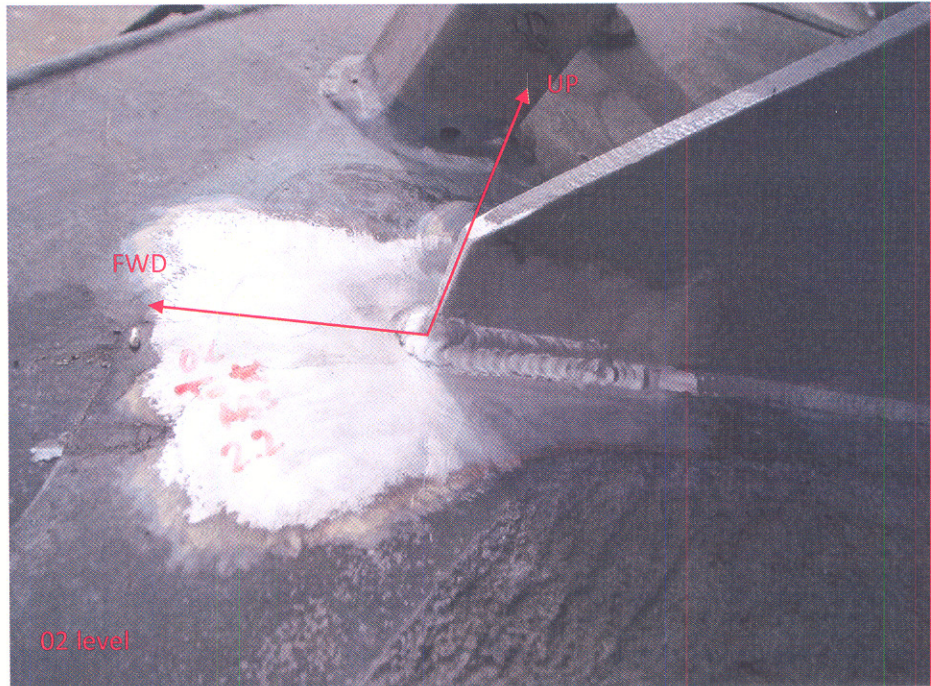
Figure 1: Frame 23, 02 Level, Radar foundation gusset

1. This crack was repaired prior to rough water trials. It has been inspected and has not re-cracked. The original crack was along the weld that connects the forward inboard gusset of the radar foundation to the 02 level deck plating.

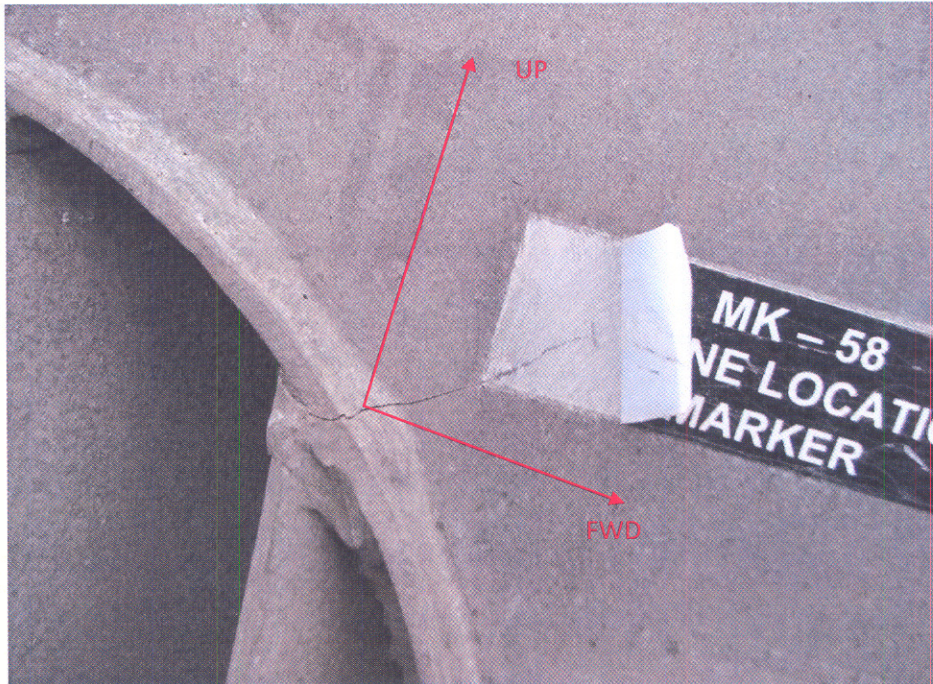
Figure 2: Frame 25, 01 Level, Intake 5-18-01-E top forward corner

2. This crack is in the top forward corner of the intake. The crack extends from the shell plating and into the collar forming the rim of the intake. Of the 6.375" total length only 3.375" is in the shell plating while the rest is in the collar itself.

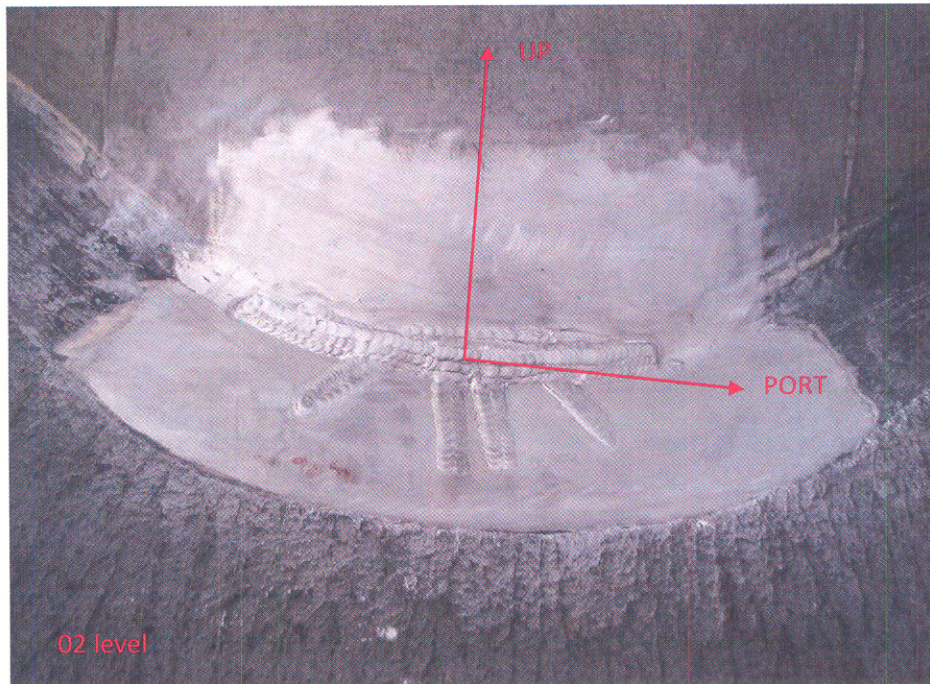
Figure 3: Frame 29, 02 Level, Deckhouse peak

3. This crack is really multiple cracks all extending from a common starting point. The cracks are in the 03 level deck plating. All had been welded over as a repair prior to getting underway. None have started to re-crack

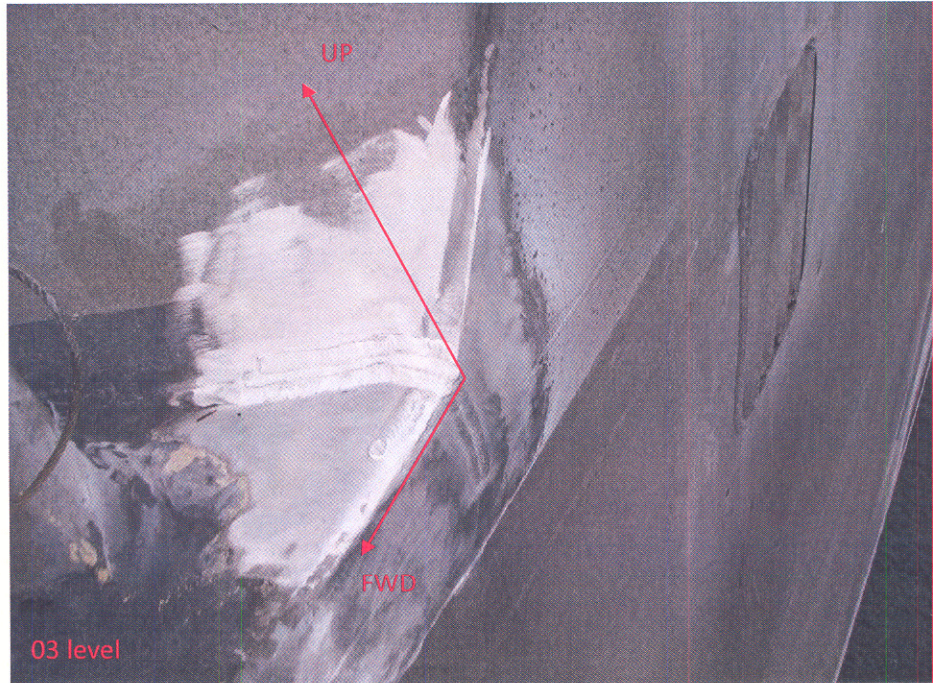
Figure 4: Frame 37, 03 Level, Deck edge, Port

4. This crack is located where the 03 level has an elevation change. It had been welded over as a repair prior to getting underway and has not re-cracked.

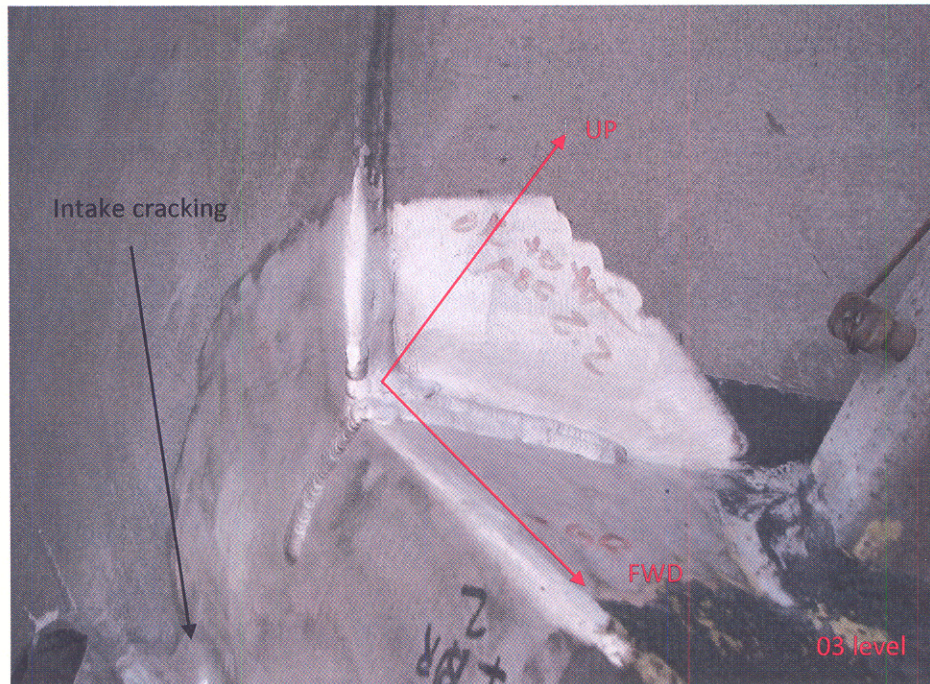
Figure 5: Frame 37, 03 Level, Deck edge, Starboard

5. This crack is the same a crack #4 but on the starboard side. Also in this same area there is a crack at the top of an intake just below the elevation change mentioned earlier. It too had been welded over as a repair prior to getting underway and has not re-cracked.

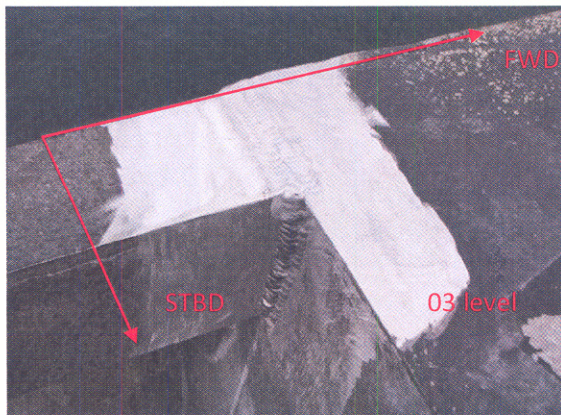
6. The re-cracking at this location was first discovered on 02/10/2011. When discovered the crack ran a total of 8.875". This weld is where the top of the shell facade that covers the rocket launch area and life boats mates to the aft exterior face of CESR #2. The crack ran 1.375" on the outboard side rounded the corner and covered the entire 5.5" upper width of the facade and then turned the corner and ran 2" down the interior of the shell. The upper portion of the facade is an upside down "U" channel. The crack runs along all three surfaces of the "U". On 02/11/2011 a 0.25" crack growth was found on the outboard portion on the crack. No crack growth was discovered until 02/13/2011. That time a growth of 0.875" was discovered on the outboard side again as well as a growth of 0.125" on the inboard side. On 02/14/2011 crack growth was again found in the outboard crack. The outboard crack now measures 3.125" and travels the complete length of the repair weld shown in Figure 9. These last two crack growths contributed to the overall length of 10.75".

Figure 6: Top left, Frame 41, 03 Level, Deck edge, Port, Crack through depth

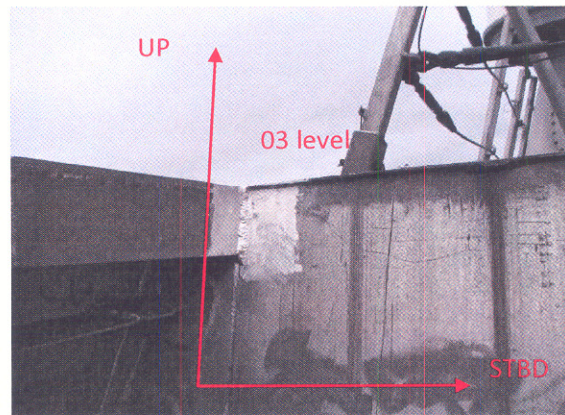
Figure 7: Top Right, Frame 41, 03 Level, Deck edge, Port, Inboard

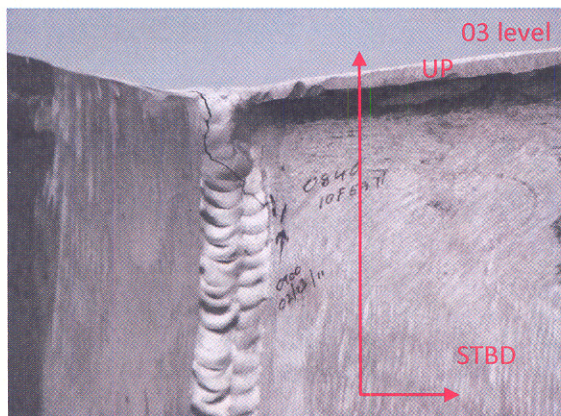
Figure 8: Bottom Left, Frame 41, 03 Level, Deck edge, Port, Inboard crack

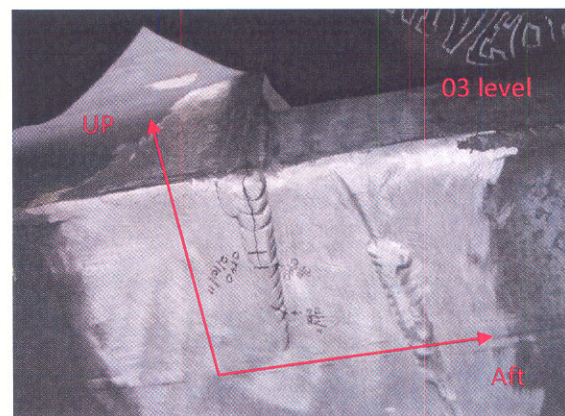
Figure 9: Bottom Right, Frame 41, 03 Level, Deck edge, Port, Outboard crack

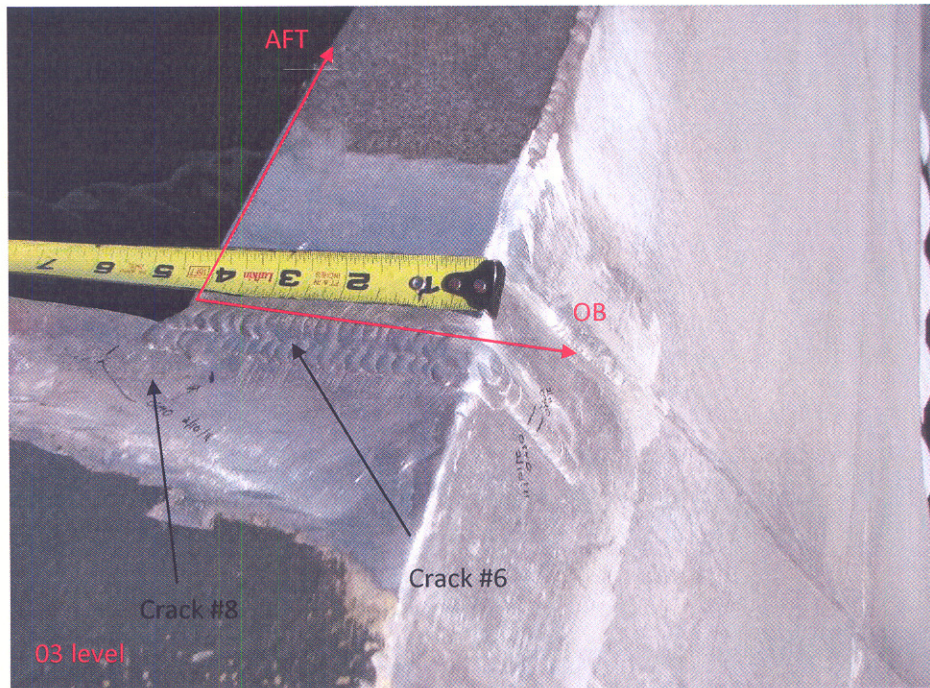
Figure 10: Frame 41, 03 Level, Deck edge, Port, Crack #8

7. The location of this crack is very close to crack #6. It is actually in the deck plating of the 03 level just forward of crack #6. It is in a slight crescent shape and was discovered on 02/10/2011 and has not grown since then. This crack measured 1.75" from tip to tip but is actually slightly longer due to the shape of the crack.

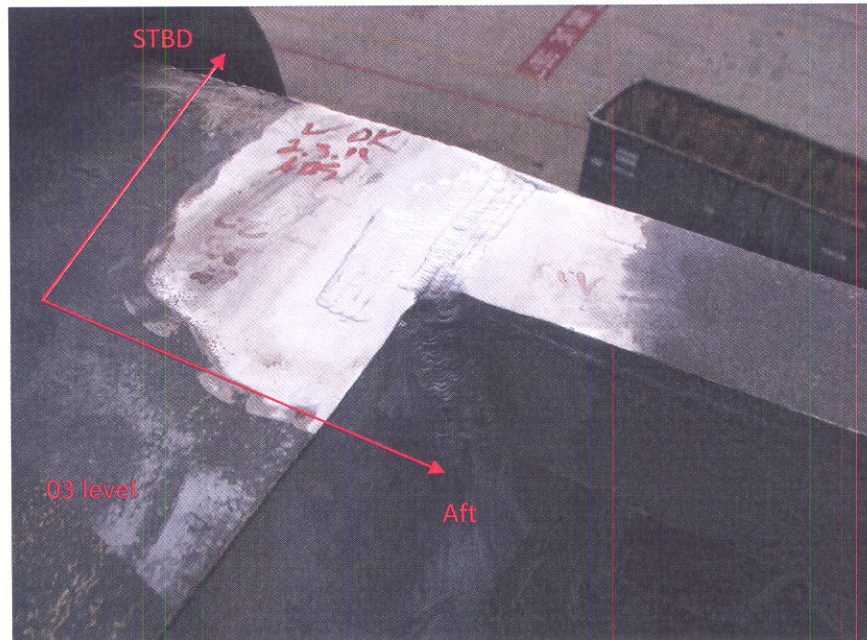
Figure 11: Frame 41, 03 Level, Deck edge, Starboard

8. This location is on the starboard side and has the same geometry as crack #6. Upon inspection of the exterior side s of the "U" no re-cracking was found. However there could be a crack on the inside of the "U". This area is hard to see and therefore hard to determine if it is a crack or something else.

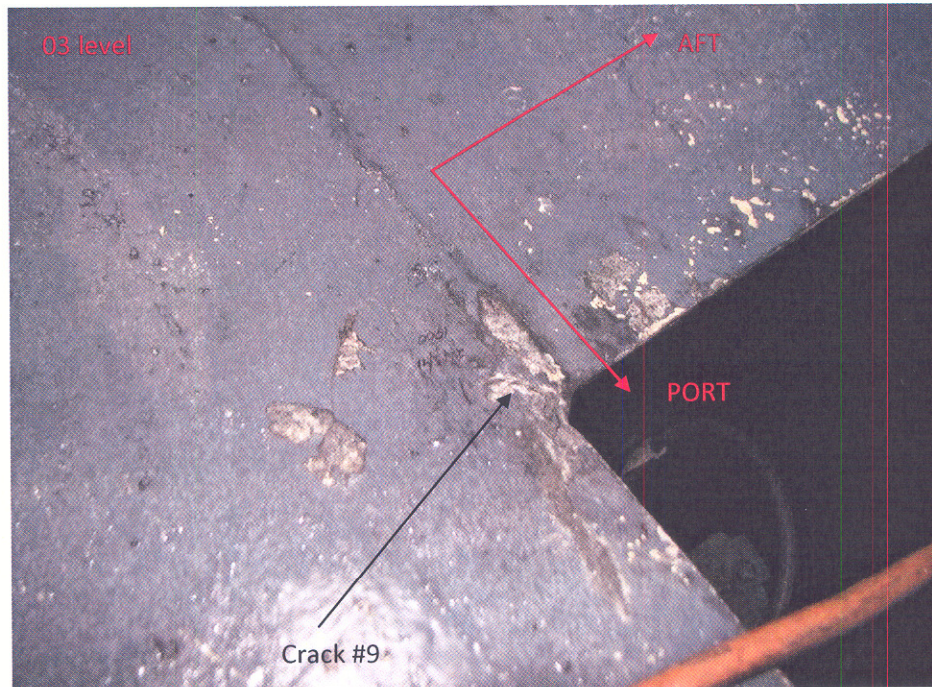
Figure 12: Frame 41, 03 Level, Port side of center walkway

9. The inspectors were not made aware of this crack until 02/13/2011 When found it measured 1.125" long. It extends from corner of a walkway on the 03 level.

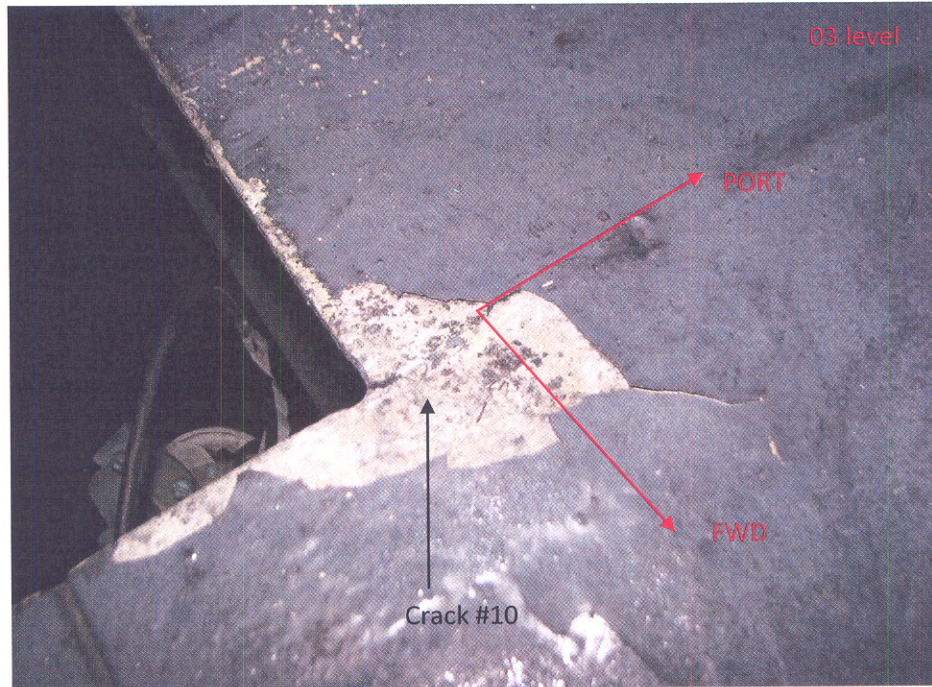
Figure 13: Frame 41, 03 Level, Starboard side of center walkway

10. This crack matches crack #9 only on the starboard side. It measured 2.25" upon discovery on 02/13/2011.

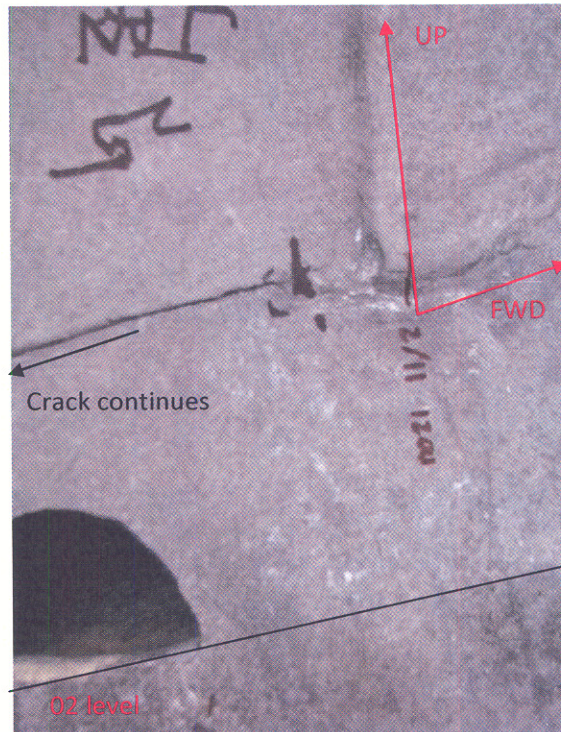
Figure 14: Frame 41.5, 02 Level, Starboard, Outboard view of shell plating

11. This crack is in the weld that mates the starboard side shell facade covering the rocket launch area to the 02 level deck plating. It was shown to us by the crew on 02/11/2011 and has not grown past the 11.125" it was when discovered.

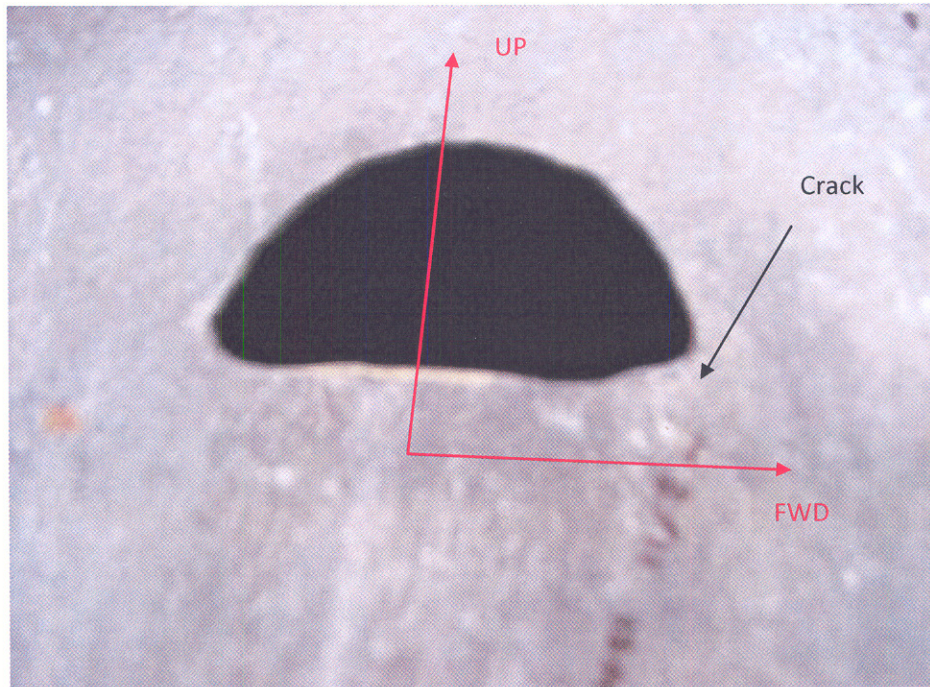
Figure 15: Frame 41.5, 02 Level, Starboard, Outboard view of shell plating, Deck drain

12. This crack was discovered the same day as crack #11. It was found when inspecting crack #11 as is in the corner of a drain hole off the 02 level.

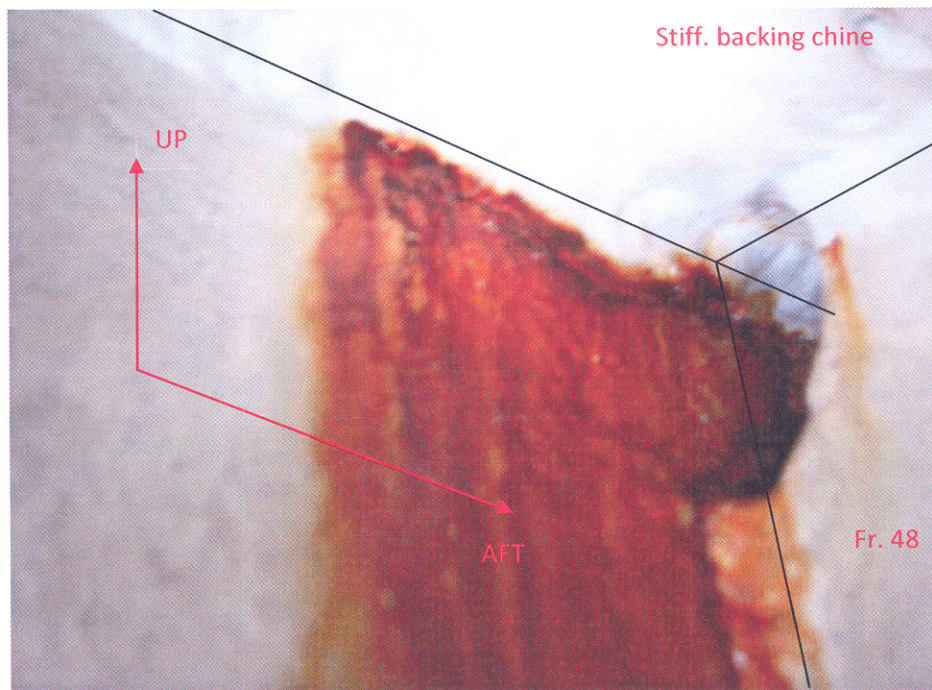
Figure 16: Frame 48, 2<sup>nd</sup> Platform, Starboard, View looking at frame 48 and chine stiffener

Due to the crack below the water line rough water trials has been suspended. These cracks will be monitored by code 65 until the ship arrives in port at San Diego, CA. Any changes to the cracks will be reported to CO Edwards and John Fulton as has been done previously.

13. This crack was discovered by a crew member. It is below the waterline and is currently allowing water in. It is located where the chine meets the lower portion of hull. It travels through a cut out in frame 48 and totals 4" in length. When discovered there was rust washing onto the painted surface. It is thought this is rust from the exposed crack surface. It is unknown how long this crack existed prior to being discovered.

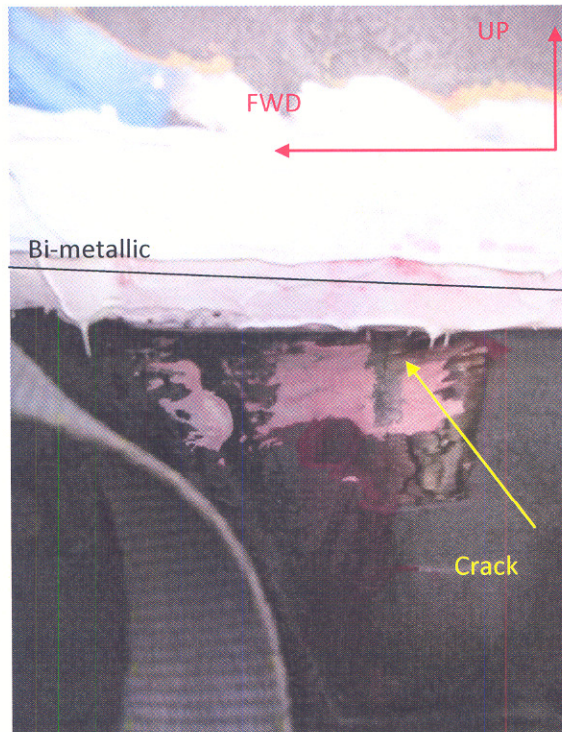
Figure 17: Frame 57, Main Deck, Port, Outboard view of shell plating

14. Crack located in steel below the bi-metallic strip. It is a vertical crack extending away from the bi-metallic strip. The crack can only be seen from the outside and with a mirror while leaning over the fashion plate. The location has been inspected each day from the inside to watch for growth through the thickness of the metal. No growth has been found.

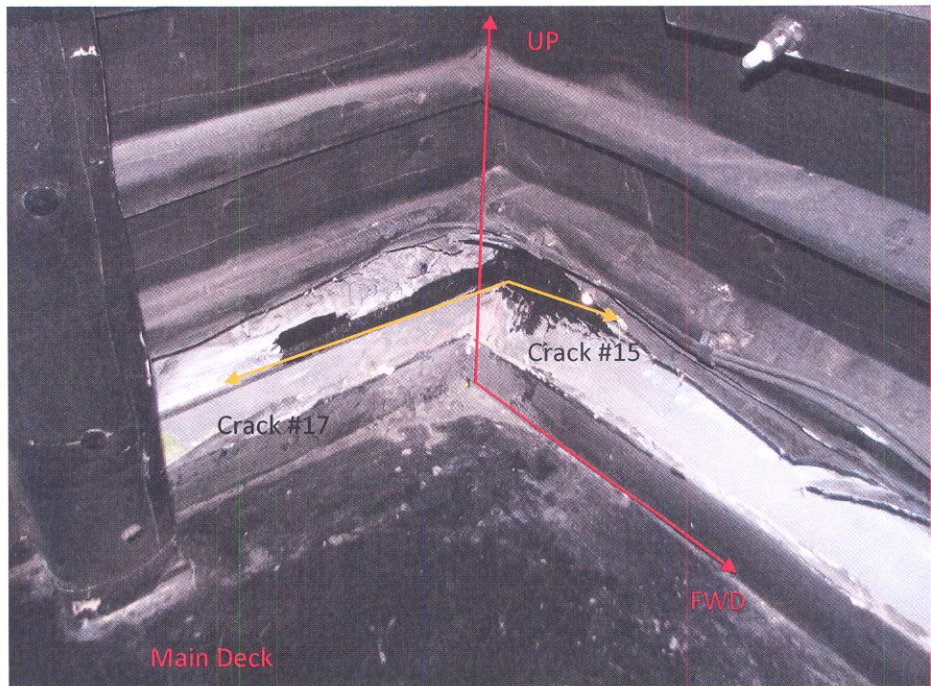
Figure 18: Frame 57, Main Deck, Port, Interior view of port aft deckhouse corner

15. Crack #15 travels from the aft port corner of the deck house forward along the upper weld of the bi-metallic strip. This crack was thought to have been mitigated with a 0.625" hole drilled through the crack tip. From the mitigation hole a growth of 1.25" was found over the course of the inspections contributed to the overall length from corner to tip of 8.5".

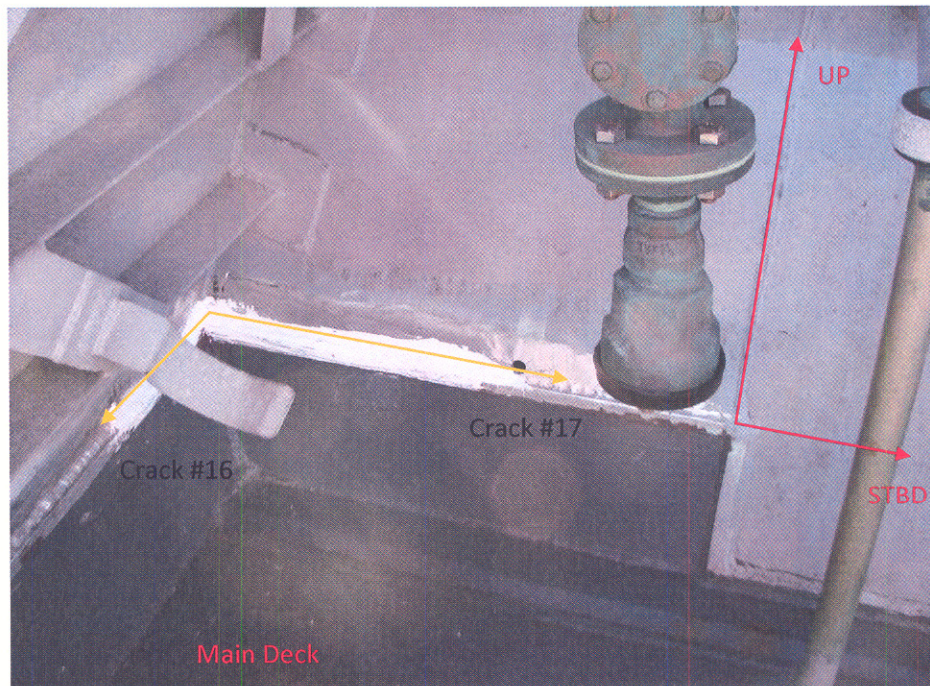
Figure 19: Frame 57, Main Deck, Port, Exterior view of port aft deckhouse corner

16. This crack starts in the same corner as crack #15. Like with crack #15 a 0.625" hole was drill in an attempt to mitigate the crack. Crack #16 travels aft along the upper weld of the bi-metallic strip through the fashion plate. The growth of 0.375" from the mitigation hole contributes to the overall length of 8.5".

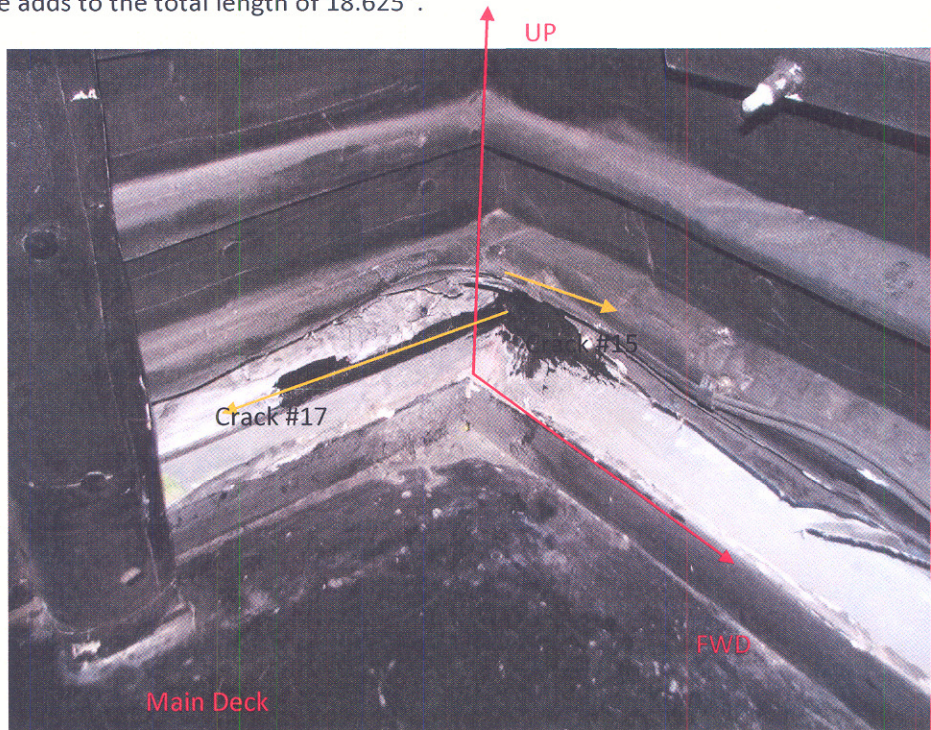
Figure 20: Frame 57, Main Deck, Port, Interior view of port aft deckhouse corner

17. Again this crack starts in the same corner as crack #15. Again a 0.625" hole was used in an attempt to mitigate the crack. The crack travels along the upper weld of the bi-metallic strip along the aft face of the deck house starting from the mitigation hole. Growth of 2.75" from the hole adds to the total length of 18.625".
